LINS. Laser Inertial Measurement System.

FINAL TECHNICAL REPORT,

July 1978

PREPARED FOR  
THE  
U.S. ARMY MISSILE RESEARCH  
AND  
DEVELOPMENT COMMAND

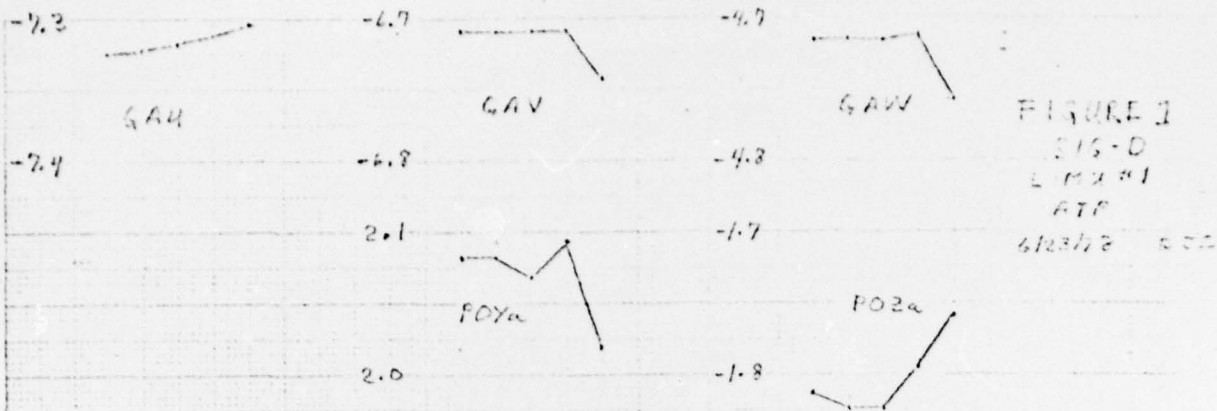
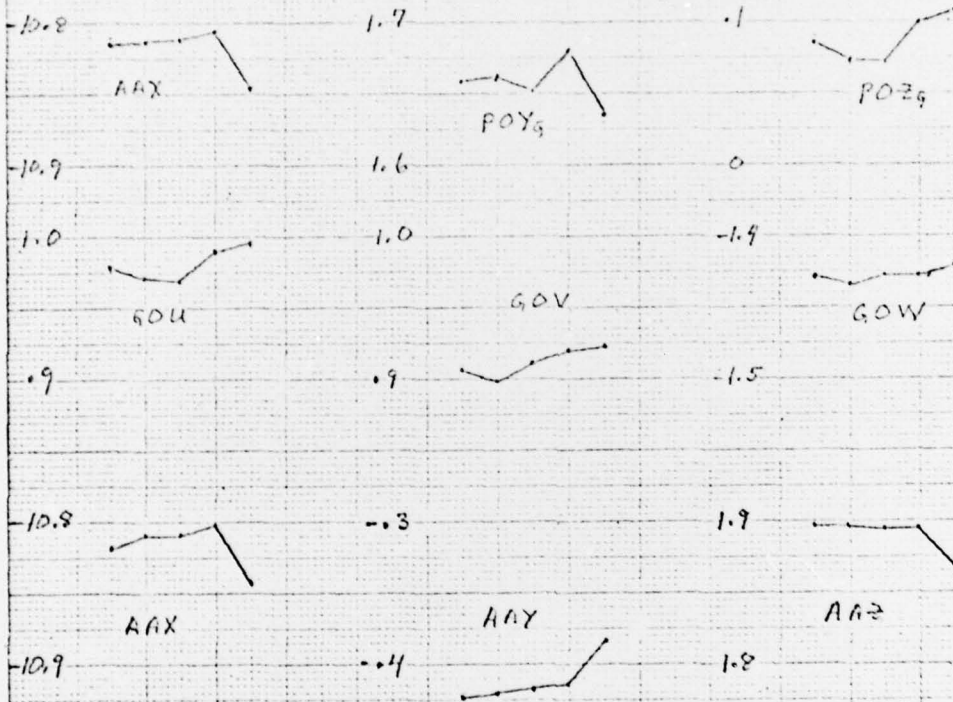
FIGURE 1

Description - The stability of the alignment of the porro prism with respect to the accelerometer triad, exceeded the 100 micro-radian ATP requirement during acceptance testing of LIMU #4 and LIMU #5. Supporting data is provided in paragraph G of this report.

NOTE: AOU, AOV SHOULD  
STABLE TO  $\pm 10$  MRR  
OVER THREE CALLS
